RHIC MACHINE PROTECTION SYSTEM UPGRADES*

M. Valette[†], D. Bruno, K.A. Drees, P.S. Dyer, R. Hulsart, J.S. Laster, J. Morris,
G. Robert-Demolaize, J. Sandberg, C. Schultheiss, T. Shrey, G.M. Tustin,
Brookhaven National Laboratory (BNL) Collider-Accelerator Department, Upton, NY, USA

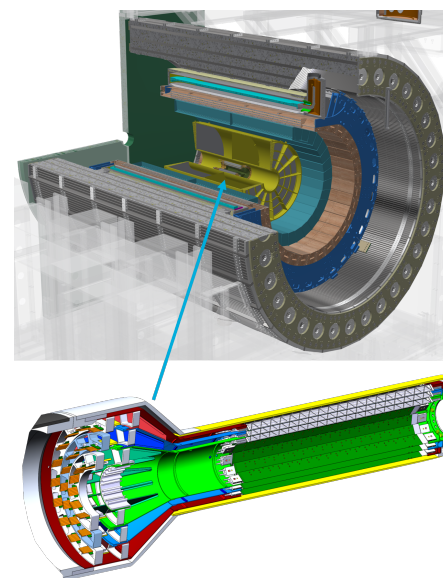
Figure 1: sPHENIX detector with MVTX vertex detector highlighted.

The PHENIX detector is being installed in IR8, upstream of collimators and one arc downstream from the Abort System on the Yellow ring. Pre-fires would cause partially kicked bunches to hit low- β IR magnets, particle showers would go through detectors and electronics, causing damage. This new Detector for nuclear physics, illustrated in Fig. 1, scheduled to run from 2023 to 2025 will feature the MVTX detector for vertex detection very close to the beam and will run with a crossing angle of 2 mrad which is the configuration where pre-fires could cause the most damage.

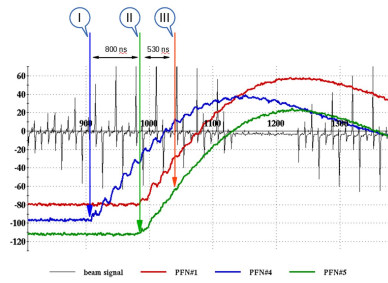
Figure 2: Timeline of a typical Abort Kicker pre-fire. Module 4, in blue, fired by itself (I) and 800 ns later the other modules re-triggered (II), here, only modules 1 and 5 are shown in red and green. The total kick from all 5 modules becomes sufficient to bring the beam to the dump absorber after 530 ns (III), leading to up to 13 bunches affected by the pre-fires with sub-nominal kick angles.

A pre-fire is a degraded behavior of the Abort Kicker system where 1 out of 5 Abort Kicker modules discharges asynchronously, the timeline of a typical pre-fire is illustrated in Figure 2. Both Blue, clockwise, and Yellow, counter-clockwise, rings are affected with around 10 events per year. Most events occur with beam in the last 20 s of the ramp (with voltages above 10.85 kV), they are assumed to be mostly a combination of high voltage and radiation. From Run 9 to Run 13, six occurrences of damage to both detectors were recorded. During Run 15, the PHENIX MPC detector was destroyed after two pre-fires. Such events must be avoided at all costs to ensure the safe operation of the sPHENIX detector.

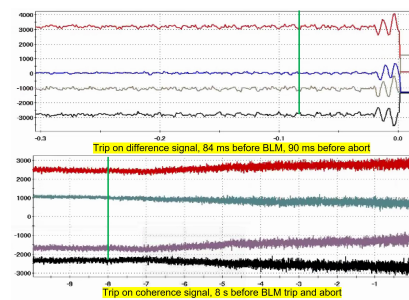
Figure 4: Illustration of BPM-MPS trips providing early detection of an ongoing failure. Top, beam oscillations caught 84 ms before an abort is issued by loss monitors. Bottom, a rising beam instability caught 8 s before loss monitors.

40 horizontal and 10 vertical beam position monitors (BPM) in each beam allow monitoring the monitoring absolute position, difference (drift speed) and coherence (min-max). of the beam in critical location like IR and snake magnets [11]. Individual thresholds are set for each BPM and signals in each RHIC mode. They feature a 10 kHz frequency for monitoring and Post Mortem, making it the fastest system in the MPS. This system has been tested operationally since 2019 and is now required for high intensity running. It allows aborting the beam milliseconds (and sometimes seconds as illustrated in Fig. 4) before losses are detected by the Beam Loss Monitors (BLM). This system unfortunately does not protect against failures that do not affect the orbit. BLMs remain the last line of defense [12].

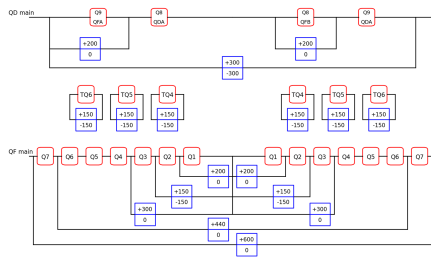
Figure 5: Schematic of the Nested Quadrupole powering scheme for RHIC interaction regions 2, 6, 8 and 12, the Q7 power supply, with 600 A, affects the current in all quadrupoles and is thus the most critical.

If a Quadrupole Power Supply (PS) were to fail, the BPMs would not detect it as the orbit is not affected. There have been several occurrences of beam aborted by BLMs during such failures in Run 20. This new system was therefore added for Run 22 with all Interaction Regions equipped, monitoring each type of power supplies in at least one building and all Q7 power supplies. Due to the nested configuration of the powering illustrated in Fig. 5, the monitoring of outer voltage taps (Q7) should allow detecting all failures. Dipole shunt power supplies will not be monitored as they affect the orbit and will be protected against by the BPMs, which was verified during commissioning.

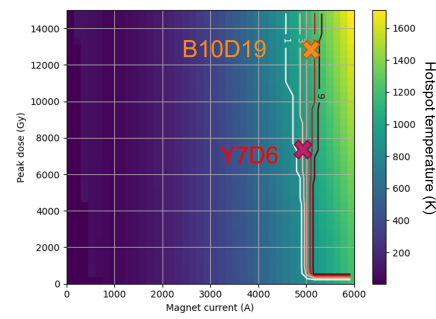
Figure 7: Parameter scan for hot-spot temperature resulting from the finite difference simulation of current crowding in bypass diodes. The contours highlight the proportion of the diode damaged during the discharge and the crosses highlight the initial conditions for two of the burnt diodes from dipole magnets.

- the inventory of diode location in cryostats to identify exposed and vulnerable diodes.
- measurements (at room and cryogenic temperatures) of turn-on voltage baseline to identify trends and signs of damaged diodes already damaged.
- simulation studies on the current crowding effect which should allow predicting the onset of damage in terms of

deposited radiation energy and magnet stored energy. The parameter scan for such simulations is illustrated in Fig. 7 and will be the topic of an upcoming paper.
