RELIABILITY AND MAINTENANCE OF PLS LINAC MECHANICAL SYSTEMS*

K. R. Kim[†], S. J. Kwon, S. H. Kim, Y. J. Park, H. G. Kim, K. W. Suh,
S. H. Nam, C. W. Chung and W. Namkung.
Pohang Accelerator Laboratory, POSTECH
Pohang, 790-784, Republic of Korea

Abstract

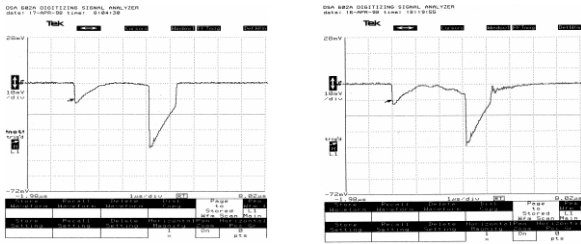
Figure 1: The RF waveform of pulse compressor output power; within temperature control of 45 ± 0.1 °C (left) and beyond temperature control of 45 ± 0.5 °C (right)[2]

There are total twelve SLED-type pulse compressors to amplify the RF power from the klystron into accelerating columns. PLS SLED consists of two TE015 mode resonant cavities, 3dB power divider, and water cooling tubes for temperature control. The cavity temperature must be held constant to within 0.3 °C to maintain the difference between the driving frequency and the cavity resonant frequency less than 16 kHz[4]. The PLS temperature control system holds the temperature fluctuations to better than ± 0.1 °C, by using independently dedicated temperature controller of SLED cavities. An example of the output power waveform of pulse compressor according to cavity temperature variation is shown in Fig. 1. Through the periodic tuning test, the system is identified so that the RF phase of the pulse compressors is sustained very stable by optimising temperature control variation of the structures.

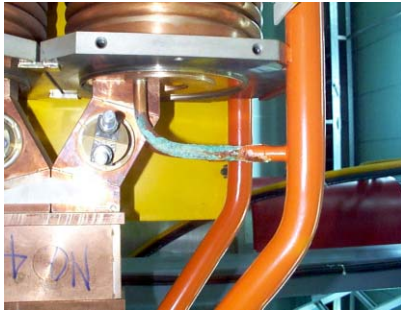
As the operation time increases, the cooling tubes for supplying the temperature-controlled water appeared the water leaks at the dissimilar metal joints such as stainless steel manifold and OFHC copper tubes. It is estimated due to the corrosive products activated by a chemical reaction under air exposure condition[5]. Figure 2 shows an example of the water leaks in joint area for the SLED

Figure 2: Water leaks in tube joint of SLED system

water supply. The more analysis of causes of corrosion will be performed in near future.

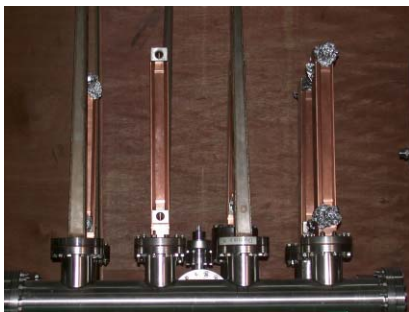
RF output load has a function of absorption of residual travelling wave around the exit of accelerating column without reflection. The direct water-cooled RF output loads produced by IHEP were initially installed in the accelerating columns. At commissioning stages, some RF loads appeared water leaks in welded joint due to the fabrication errors. Recently, new indirect RF output load using SiC ceramic developed by H. Matsumoto[6] was adopted to prevent the water leaks. SiC loads was successfully operated with up to 50-MW of RF power at a 1 μ s pulse width and 50 Hz repetition rate in the 2856 MHz. The input VSWR obtained was less than 1:1.1 at the maximum RF power. In order to prevent the water leaks by micro-cracks on the welding point of the water-cooled output loads, the newly designed SiC loads were prepared and replaced. Six modules including preinjector in PLS linac have been replaced with SiC output loads. The fabricated SiC loads and water loads under vacuum processing are shown Fig. 3.

Figure 3: SiC loads and water-cooled RF loads under vacuum processing
