THE LASL HIGH-DUTY-FACTOR ION SOURCE*

C. R. Emigh and Donald W. Mueller
 University of California, Los Alamos Scientific Laboratory
 Los Alamos, New Mexico

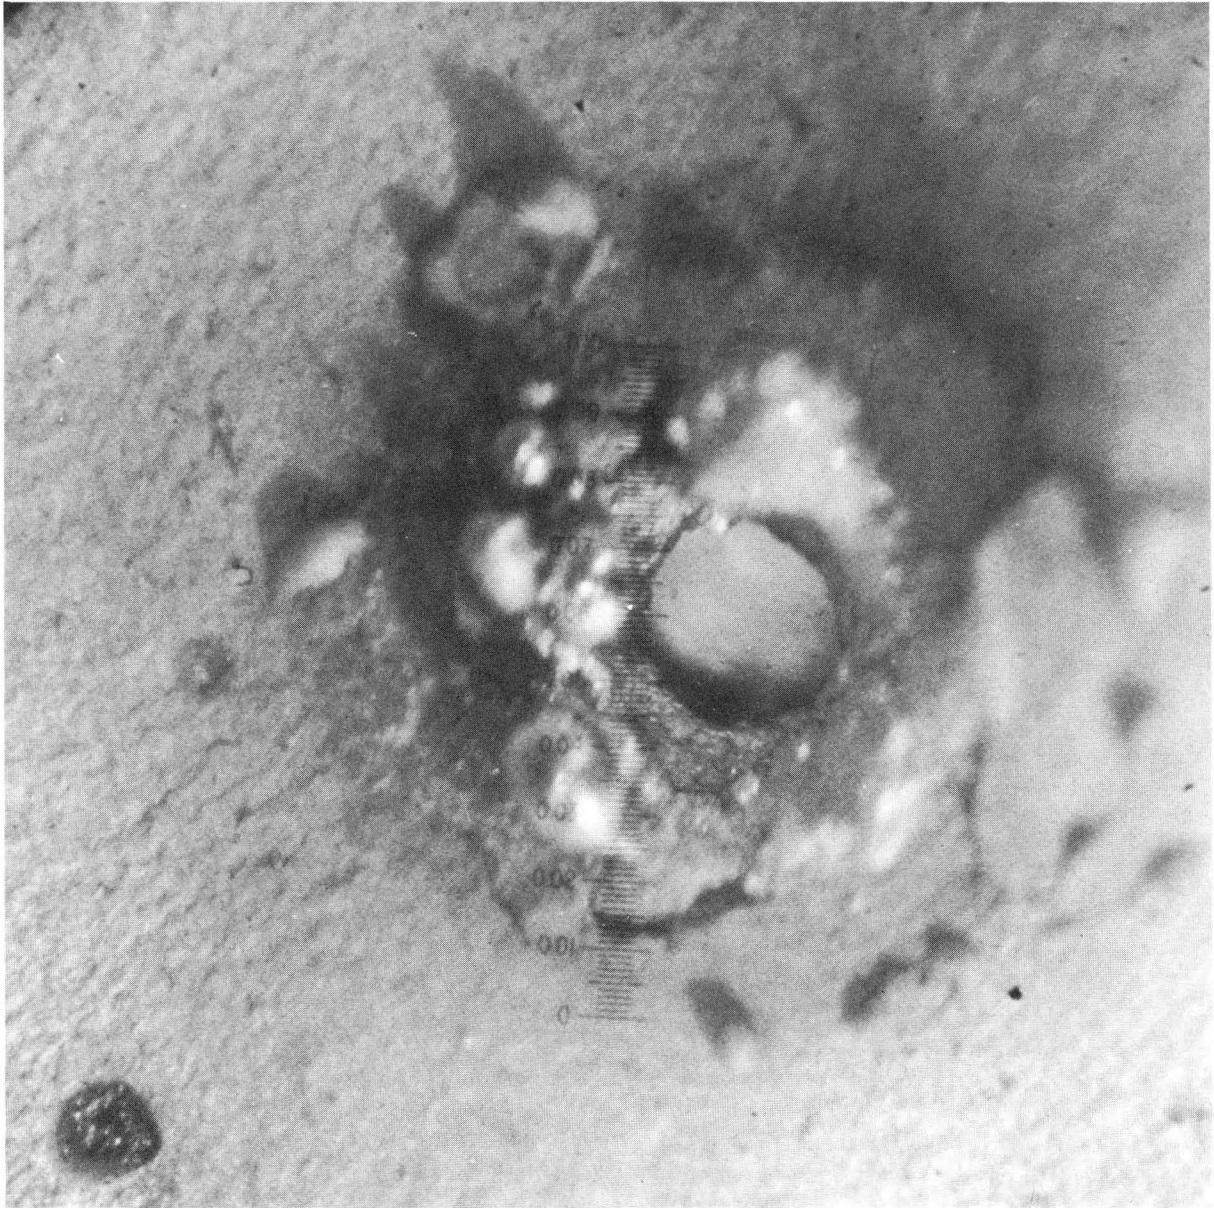
In the region of 6 to 12% DF, the plasma aperture (see region E of Fig. 10) appears to be the only component of the ion source that must be operating close to the limits at which failure will occur. This marginal situation is associated with the use of soft iron for the thin plasma aperture system used to ensure a nearly field-free region in the expansion cup. This iron septum is 0.005-in. thick with a layer of copper of the same thickness joined to it by silver solder. The diameter of the aperture was 0.040 in. After the 6% DF test, an examination of the aperture showed little damage. After the 12% DF test, the aperture showed some melting with a resulting globular structure (see Fig. 12). Further design improvements will be necessary for 12% DF operation.

Fig.12. Photomicrograph of plasma aperture from the intermediate electrode side after 12% duty factor life test.

BENJAMIN, BNL: In your last photograph, of the damage on the back of the aperture in the duoplasmatron, it appeared as if the damage was on one side of the aperture. Could this damage be due to mechanical misalignment?

MUELLER, LASL: The damage area is elliptical in the case shown. Our apertures are not so nicely centered as the Brookhaven apertures. At BNL, centering is done by gluing the intermediate electrode to the anode insulator before final machining of the centering rings. We simply center ours with an alignment gauge. I believe our centering is good to about 0.001" however.
